Request for Quotes

The City of Exira is seeking quotations for asbestos survey and testing on eight buildings (eleven facades) within the Main Street District. This is a part of Downtown Façade Rehabilitation project. The testing will be on suspect materials that have the potential to be disturbed on or within the building during demolition or construction. The project will encompass façade modifications only. Buildings in which testing is required can be found in the appendix of this document.

**EXIRA
 FACADE
 REHABILITATION**

The Franks Design Group, PC

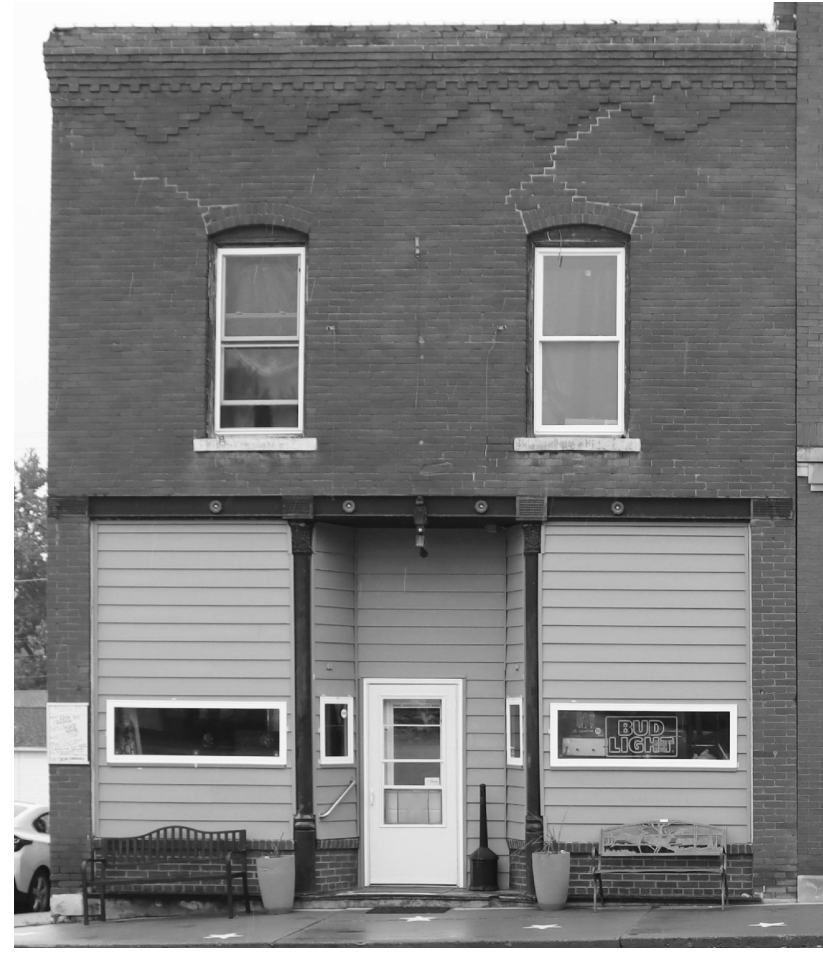
EXISTING PHOTO

EXTERIOR WALLS: FAIR
 STOREFRONTS: FAIR
 ENTRYWAYS: POOR
 WINDOWS: POOR
 FRONT FOUNDATION: POOR
 PORCH, STAIRS, DECK RAMP: POOR
 AWNINGS/SIGNAGE: POOR
 ROOF: NOT OBSERVED

- MASONRY REPAIR/RESTORATION: TUCK POINT EXPOSED BRICK WITH APPROPRIATE RESTORATION MORTAR AS DETERMINED BY MORTAR ANALYSIS. COLOR, TEXTURE, AND CHEMICAL COMPOSITION TO BE INFORMED BY ANALYSIS AND ARCHITECT APPROVED
- STOREFRONTS: REPLACE STOREFRONT WINDOW & DOORS WITH NEW INSULATED GLASS STOREFRONT SYSTEM
- UPPER STORY WINDOWS: EXISTING UPPER STORY WINDOWS TO REMAIN; REPAIR WOOD FRAMES AS REQUIRED; PREP & PAINT
- FRONT FOUNDATION: REPAIR BRICKS & TUCK POINT LARGE OPEN GAPS AT MASONRY NEAR BOTTOM FOUNDATION
- PAINT: PREP AND PAINT EXISTING CAST IRON COLUMNS OR EXTERIOR MATERIAL WITH PANELIZED MULTI-COLOR SCHEME INCLUDING UPPERSTORY WINDOWS
- CAST IRON PLATE: ADDRESS ISSUE OF CAST IRON PLATE AT ENTRY DOOR

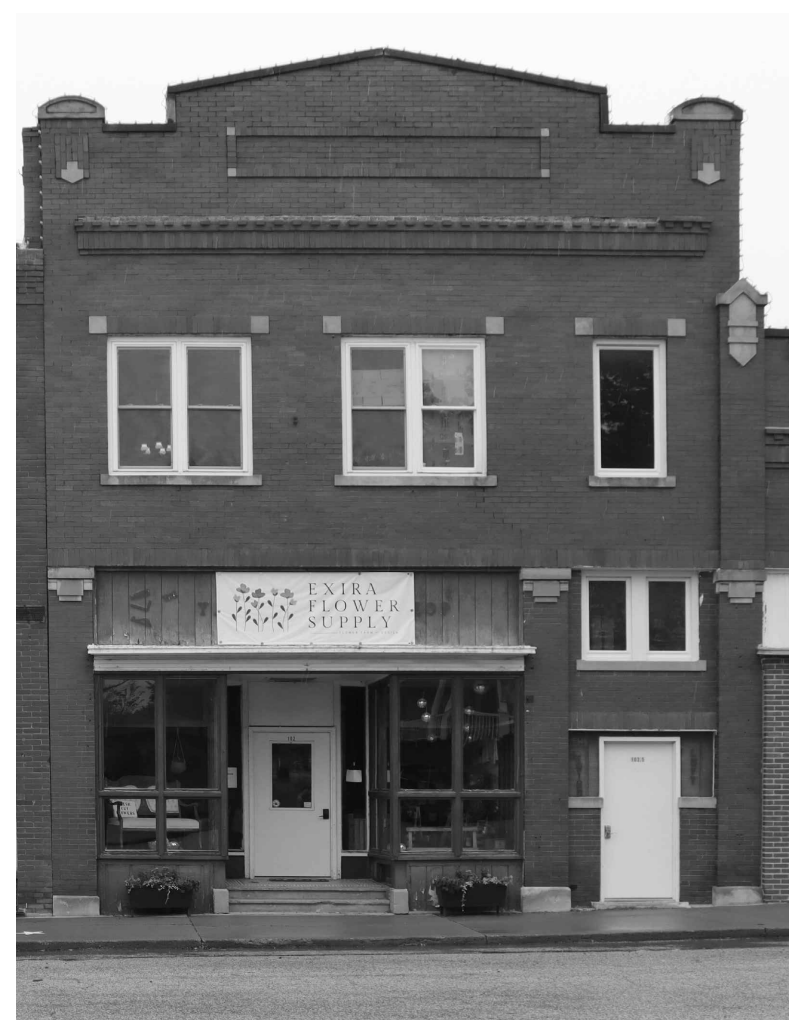
EXISTING PHOTO

EXTERIOR WALLS: FAIR
 STOREFRONTS: POOR
 ENTRYWAYS: FAIR
 UPPER STORY WINDOWS: FAIR
 FRONT FOUNDATION: FAIR
 PORCH, STAIRS, DECK RAMP: FAIR
 AWNINGS/SIGNAGE: FAIR
 ROOF: NOT OBSERVED

- MASONRY REPAIR/RESTORATION: TUCK POINT EXPOSED BRICK WITH APPROPRIATE RESTORATION MORTAR AS DETERMINED BY MORTAR ANALYSIS. COLOR, TEXTURE, AND CHEMICAL COMPOSITION TO BE INFORMED BY ANALYSIS AND ARCHITECT APPROVED

- STOREFRONTS: REPLACE STOREFRONT WINDOW & DOORS WITH NEW INSULATED GLASS ALUMINUM STOREFRONT SYSTEM
- TRANSOM: INSTALL NEW ALUMINUM FRAMED CLEAR INSULATING GLASS AT TRANSOM AREA.

- UPPER STORY WINDOWS: EXISTING WINDOWS TO REMAIN; CAULK AND SEAL EDGES AS REQUIRED
- FRONT FOUNDATION: CAULK AT FOUNDATION AS REQUIRED.
- KICK PANEL: REMOVE EXISTING INFILL; INSTALL NEW PANELIZED FIBER CEMENT KICKPANEL

- PAINT: PREP AND PAINT EXISTING PAINTED EXTERIOR ELEMENTS WITH PANELIZED MULTI-COLOR SCHEME; PREP & PAINT UNDERSIDE OF SOFFIT, TRANSOM BAND WHERE FORMER AWNING COVER REMAINS.

- WOOD DOOR: INSTALL NEW WOOD ENTRY DOOR TO SECOND STORY WITH SIDE LITES.
- TILES: EXISTING TILES AT RECESSED ENTRY TO REMAIN; GROUT AND SEAL TILES AS REQUIRED.

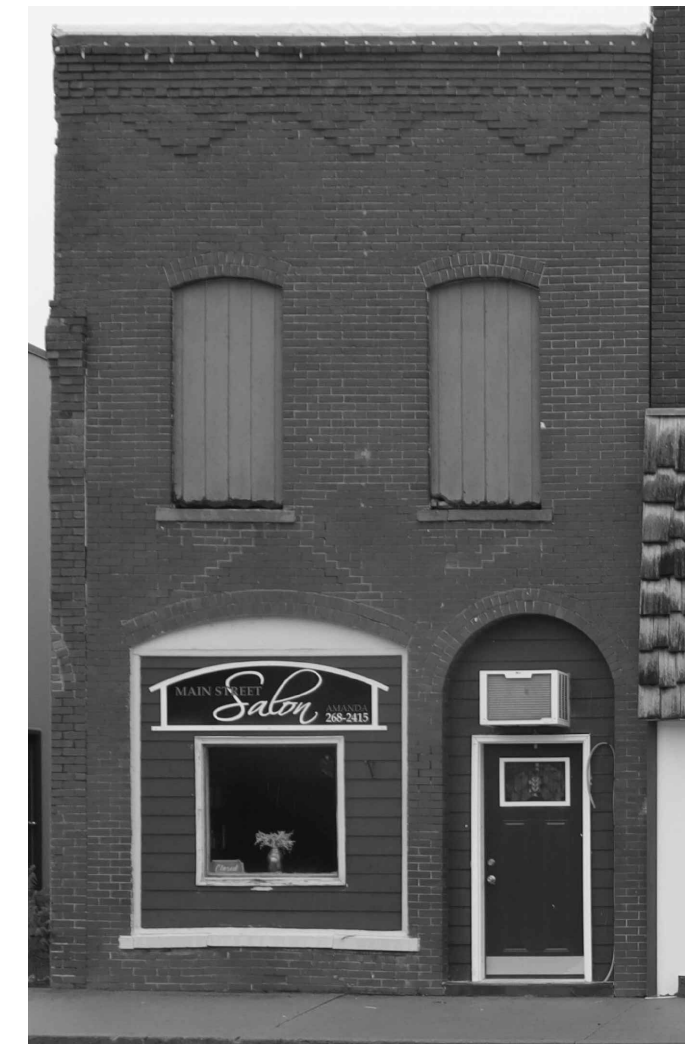
EXISTING PHOTO

EXTERIOR WALLS:	POOR
STOREFRONTS:	FAIR
ENTRYWAYS:	POOR
WINDOWS:	FAIR
FRONT FOUNDATION:	NOT VISIBLE
PORCH, STAIRS, DECK, RAMP:	NONE
AWNINGS/SIGNAGE:	FAIR
ROOF:	NOT OBSERVED

- MASONRY REPAIR/RESTORATION: TUCK POINT EXPOSED BRICK WITH APPROPRIATE RESTORATION MORTAR AS DETERMINED BY MORTAR ANALYSIS. COLOR, TEXTURE, AND CHEMICAL COMPOSITION TO BE INFORMED BY ANALYSIS AND ARCHITECT APPROVED
- STOREFRONTS: REPLACE STOREFRONT WINDOW & DOORS WITH NEW INSULATED GLASS STOREFRONT SYSTEM
- UPPER STORY WINDOWS: REPLACE UPPER-STORY WINDOWS WITH NEW WOOS DOUBLE HUNG WINDOWS
- STONE: FILL GAPS AND CLEAN STONE AS REQUIRED
- PAINT: PREP AND PAINT EXISTING CONCRETE WINDOW SILL AND/OR ANY OTHER PAINTED EXTERIOR ELEMENTS

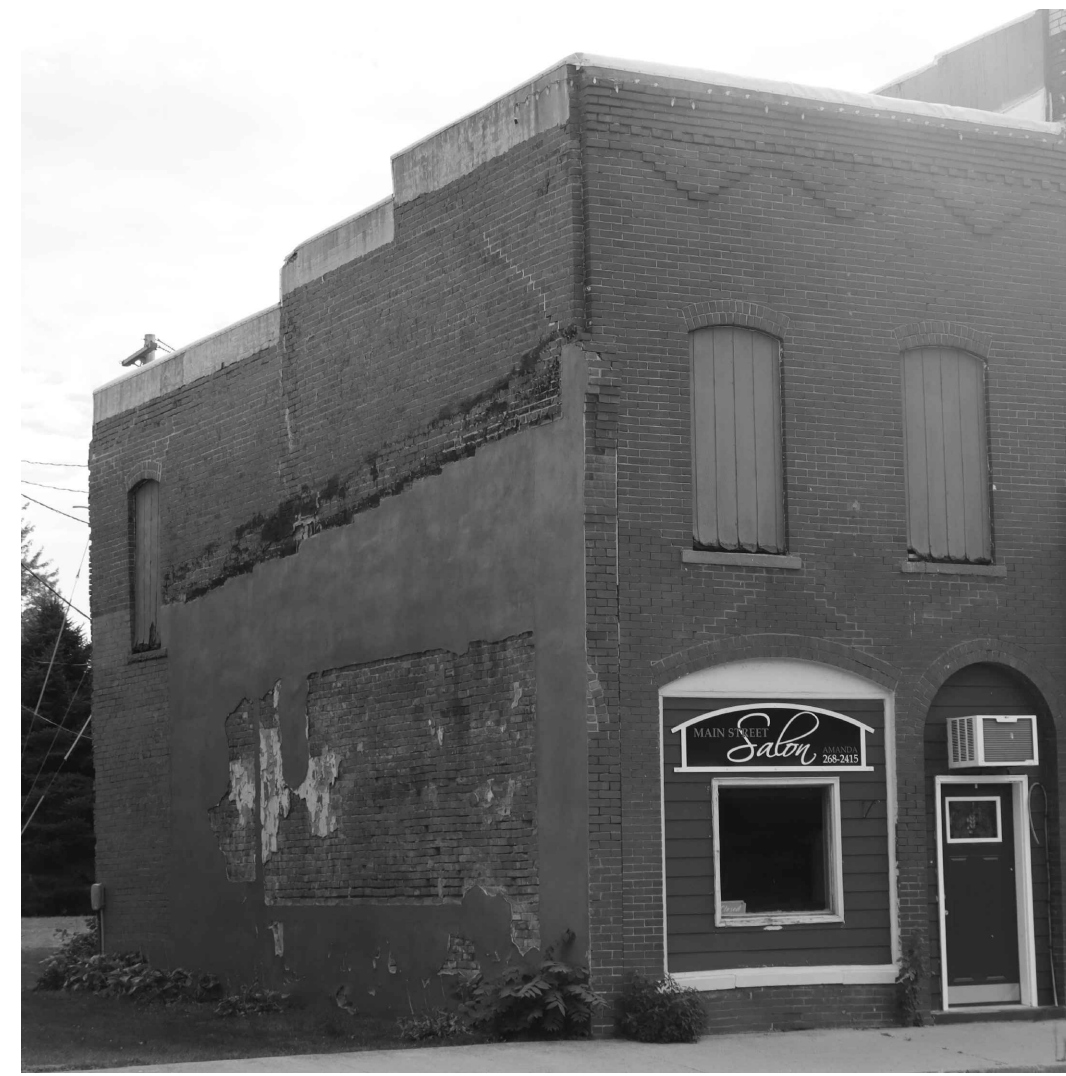
EXISTING PHOTO

EXTERIOR WALLS: FAIR
 STOREFRONTS: POOR
 ENTRYWAYS: POOR
 WINDOWS: POOR
 FRONT FOUNDATION: NOT VISIBLE
 PORCH, STAIRS, DECK RAMP: N/A
 AWNINGS/SIGNAGE: NONE
 ROOF: NOT OBSERVED

- MASONRY REPAIR/RESTORATION: TUCK POINT EXPOSED BRICK WITH APPROPRIATE RESTORATION MORTAR AS DETERMINED BY MORTAR ANALYSIS. COLOR, TEXTURE, AND CHEMICAL COMPOSITION TO BE INFORMED BY ANALYSIS AND ARCHITECT APPROVED
- UPPER STORY WINDOWS: REPLACE UPPER-STORY WINDOWS WITH NEW WOOD DOUBLE HUNG WINDOWS; INSTALL NEW CAST STONE SILL UNDER UPPER STORY WINDOW
- EFIS: INSTALL NEW EFIS WHERE EXISTING EFIS WAS PREVIOUSLY INSTALLED
- PAINT: PREP AND PAINT EXISTING NEW/EXISTING EFIS OR EXTERIOR MATERIAL WITH PANELIZED MULTI-COLOR SCHEME INCLUDING UPPERSTORY WINDOWS .

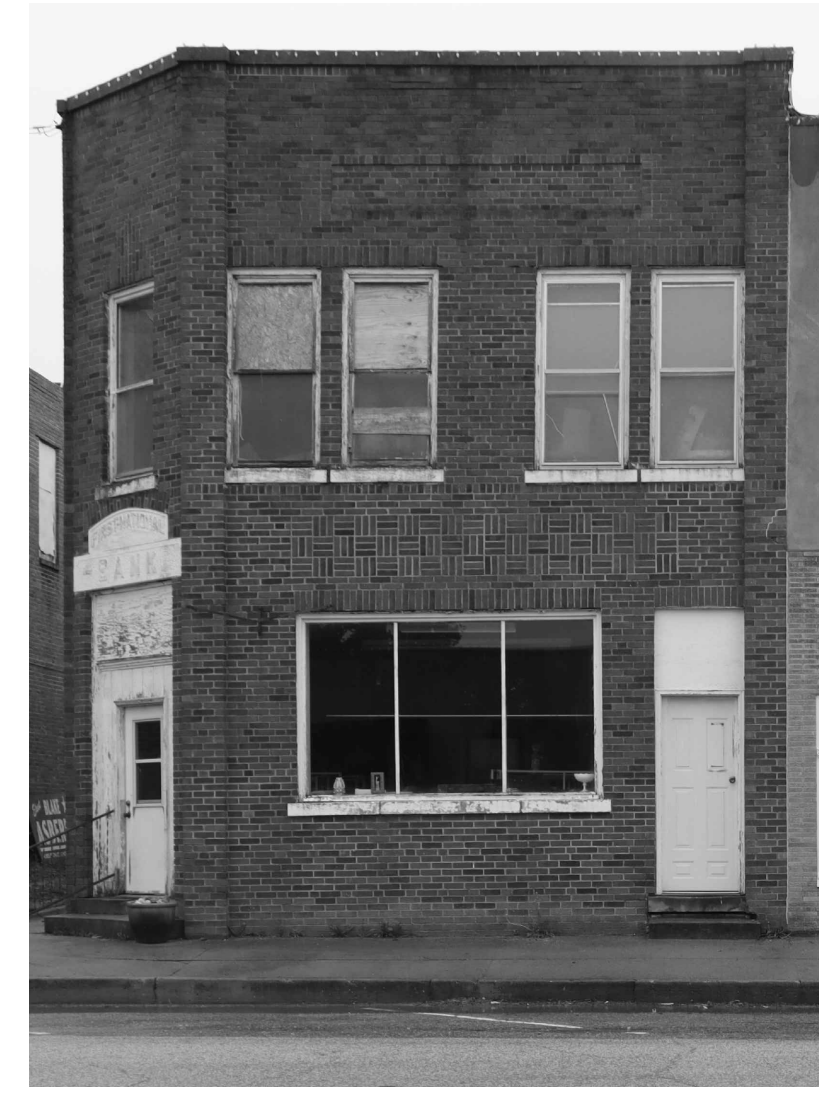
EXISTING PHOTO

EXTERIOR WALLS: FAIR
 STOREFRONTS: POOR
 ENTRYWAYS: POOR
 WINDOWS: POOR
 FRONT FOUNDATION: FAIR
 PORCH, STAIRS, DECK, RAMP: FAIR
 AWNINGS/SIGNAGE: NONE
 ROOF: POOR

- MASONRY REPAIR/RESTORATION: TUCK POINT EXPOSED BRICK WITH APPROPRIATE RESTORATION MORTAR AS DETERMINED BY MORTAR ANALYSIS. COLOR, TEXTURE, AND CHEMICAL COMPOSITION TO BE INFORMED BY ANALYSIS AND ARCHITECT APPROVED
- STOREFRONTS: REPLACE STOREFRONT WINDOW & DOORS WITH NEW INSULATED GLASS STOREFRONT SYSTEM
- UPPER STORY WINDOWS: REPLACE UPPER-STORY WINDOWS WITH NEW WOOD DOUBLE HUNG.
- FRONT FOUNDATION: CAULK AT FOUNDATION AS REQUIRED.
- PAINT: PREP AND PAINT EXISTING CORNICE OR EXTERIOR MATERIAL WITH PANELIZED MULTI-COLOR SCHEME INCLUDING UPPERSTORY WINDOWS .

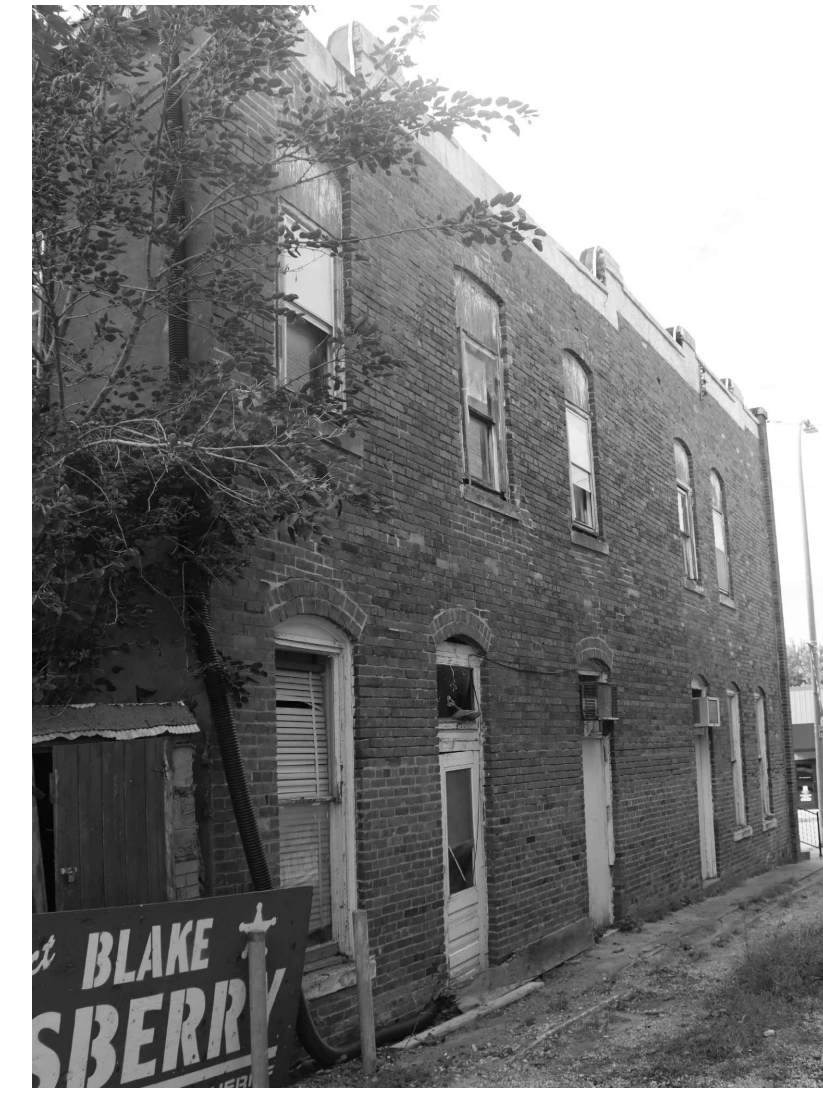
EXISTING PHOTO

EXTERIOR WALLS: POOR
 STOREFRONTS: POOR
 ENTRYWAYS: POOR
 WINDOWS: POOR
 FRONT FOUNDATION: FAIR
 PORCH, STAIRS, DECK, RAMP: NONE
 AWNINGS/SIGNAGE: NONE
 ROOF: POOR

- MASONRY REPAIR/RESTORATION: TUCK POINT EXPOSED BRICK WITH APPROPRIATE RESTORATION MORTAR AS DETERMINED BY MORTAR ANALYSIS. COLOR, TEXTURE, AND CHEMICAL COMPOSITION TO BE INFORMED BY ANALYSIS AND ARCHITECT APPROVED
- STOREFRONTS: REPLACE STOREFRONT DOORS WITH NEW INSULATED GLASS STOREFRONT SYSTEM
- UPPER STORY WINDOWS: REPLACE UPPER-STORY WINDOWS WITH NEW
- STRUCTURAL REPAIRS: STRUCTURALLY STABILIZE THE BUILDING AS REQUIRED.
- PAINT: PREP AND PAINT EXISTING CORNICE OR EXTERIOR MATERIAL WITH PANELIZED MULTI-COLOR SCHEME INCLUDING UPPERSTORY WINDOWS .

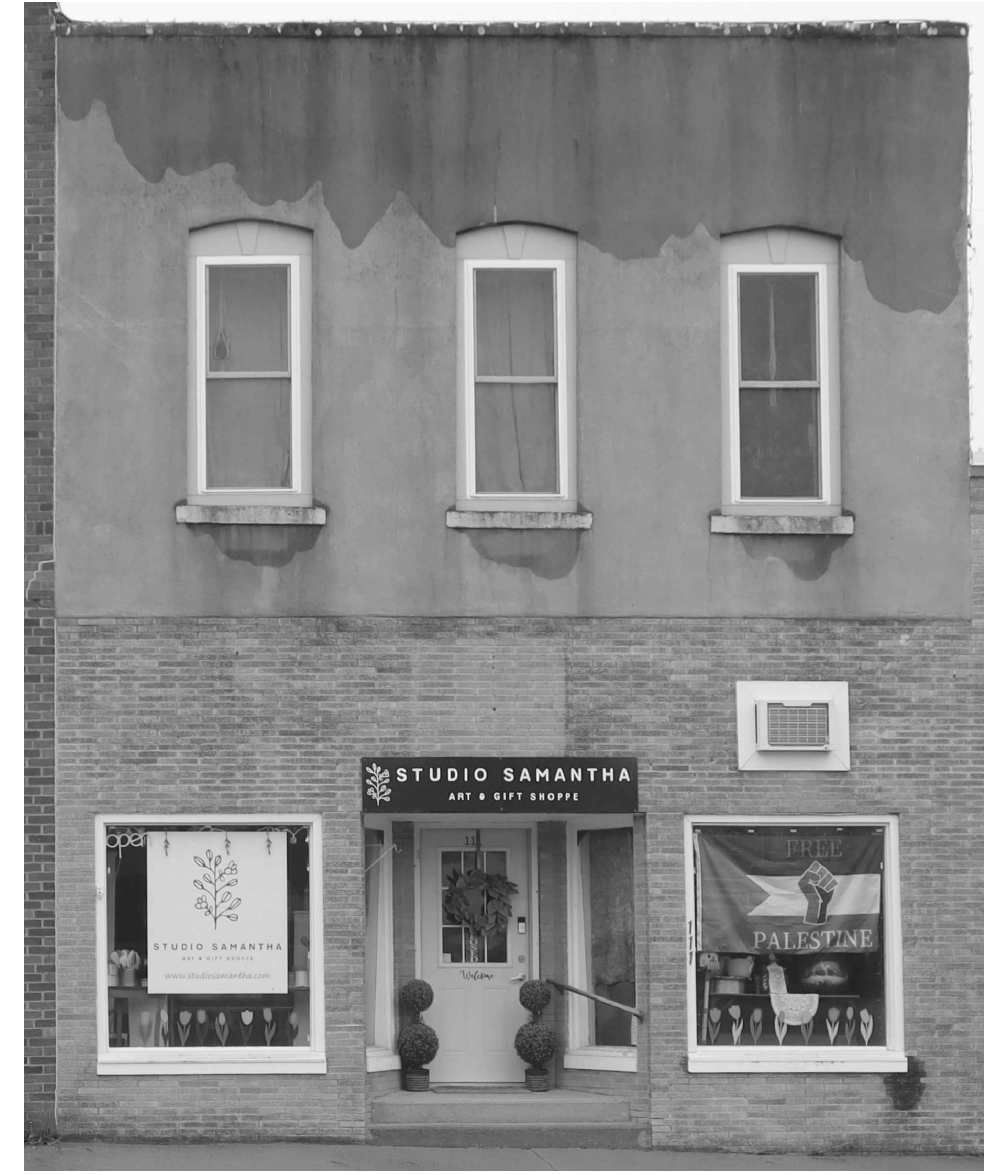
EXISTING PHOTO

EXTERIOR WALLS: NOT EVALUATED YET
 STOREFRONTS: NOT EVALUATED YET
 ENTRYWAYS: NOT EVALUATED YET
 WINDOWS: NOT EVALUATED YET
 FRONT FOUNDATION: NOT EVALUATED YET
 PORCH, STAIRS, DECK, RAMP: NOT EVALUATED YET
 AWNINGS/SIGNAGE: NOT EVALUATED YET
 ROOF: NOT EVALUATED YET

- MASONRY REPAIR/RESTORATION: LIGHT TUCK POINT EXPOSED BRICK WITH APPROPRIATE RESTORATION MORTAR AS DETERMINED BY MORTAR ANALYSIS. COLOR, TEXTURE, AND CHEMICAL COMPOSITION TO BE INFORMED BY ANALYSIS AND ARCHITECT APPROVED CLEAN BRICK
- STOREFRONTS: REPLACE STOREFRONT WINDOW & DOORS WITH NEW INSULATED GLASS STOREFRONT SYSTEM
- UPPER STORY WINDOWS: REPLACE UPPER-STORY WINDOWS WITH NEW
- FRONT FOUNDATION: CAULK AT FOUNDATION AS REQUIRED.
- ROOF: INSTALL NEW ROOFING
- PAINT: PREP AND PAINT EXISTING CORNICE OR EXTERIOR MATERIAL WITH PANELIZED MULTI-COLOR SCHEME INCLUDING UPPERSTORY WINDOWS .

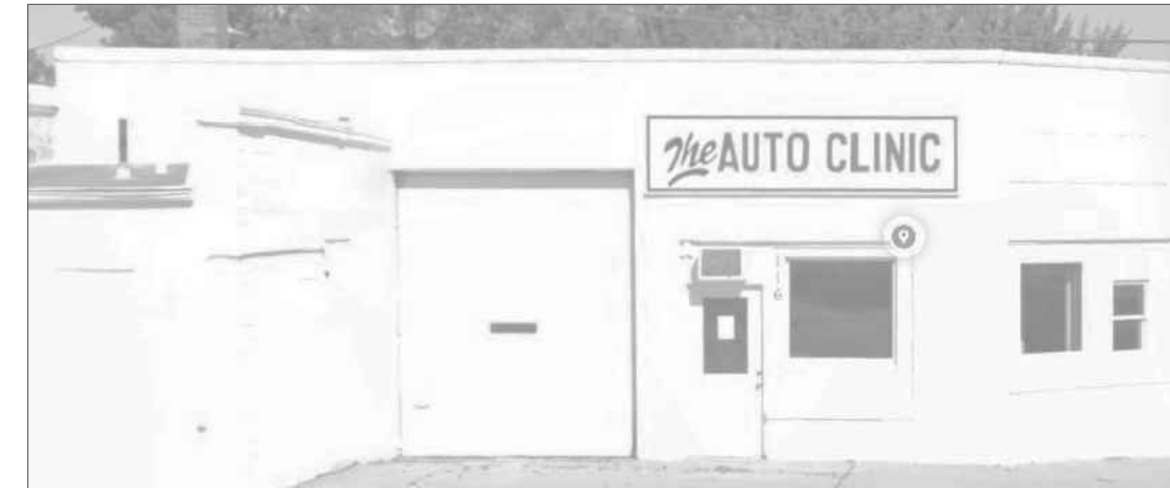
EXISTING PHOTO

EXTERIOR WALLS: FAIR
 STOREFRONTS: FAIR/POOR
 ENTRYWAYS: POOR
 WINDOWS: N/A
 FRONT FOUNDATION: NOT VISIBLE
 PORCH, STAIRS, DECK RAMP: N/A
 AWNINGS/SIGNAGE: FAIR
 OTHER: OVERHEAD DOORS - POOR

- MASONRY REPAIR/RESTORATION: TUCK POINT EXPOSED BLOCK WITH APPROPRIATE MORTAR AS DETERMINED BY MORTAR ANALYSIS. COLOR, TEXTURE, AND CHEMICAL COMPOSITION TO BE INFORMED BY ANALYSIS AND ARCHITECT APPROVED
- STOREFRONTS: REPLACE STOREFRONT WINDOWS @ GROUND LEVEL WITH NEW INSULATED GLASS ALUMINUM FRAMED STOREFRONT SYSTEM, INCLUDING NEW OVERHEAD DOORS AS INDICATED BY DRAWING ELEVATION.
- OVERHEAD DOORS: INSTALL NEW OVERHEAD DOORS
- PAINT: PREP AND PAINT EXISTING BLOCKING OR EXTERIOR MATERIAL.
- MASONRY INFILLS: INSTALL NEW FACE BRICK @ EXISTING MASONRY OPENINGS

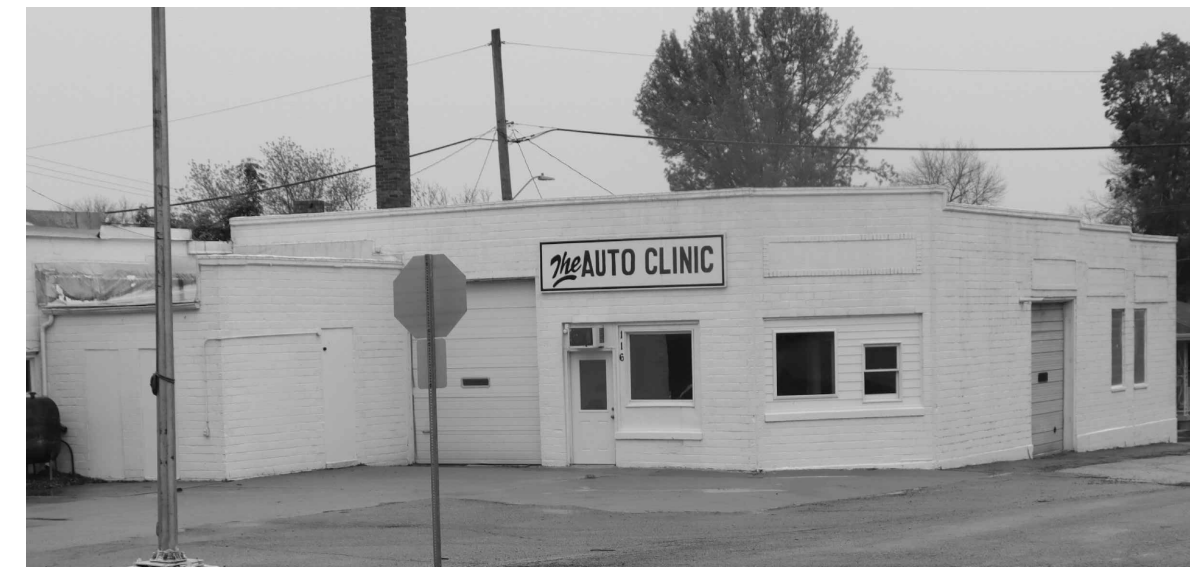
EXISTING PHOTO

EXTERIOR WALLS: FAIR
 STOREFRONTS: FAIR/POOR
 ENTRYWAYS: POOR
 UPPER WINDOWS: N/A
 FRONT FOUNDATION: N/A
 PRCH, STAIRS, DECK RAMP: FAIR
 AWNINGS/SIGNAGE: N/A
 OTHER: OVERHEAD DOORS - POOR

- MASONRY REPAIR/RESTORATION: TUCK POINT EXPOSED BLOCK WITH APPROPRIATE MORTAR AS DETERMINED BY MORTAR ANALYSIS. COLOR, TEXTURE, AND CHEMICAL COMPOSITION TO BE INFORMED BY ANALYSIS AND ARCHITECT APPROVED
- STOREFRONTS: REPLACE STOREFRONT WINDOWS @ GROUND LEVEL WITH NEW INSULATED GLASS ALUMINUM FRAMED STOREFRONT SYSTEM. INCLUDING NEW OVERHEAD DOORS AS INDICATED BY DRAWING ELEVATION.
- OVERHEAD DOORS: INSTALL NEW OVERHEAD DOORS
- PAINT: PREP AND PAINT EXISTING BLOCKING OR EXTERIOR MATERIAL.
- MASONRY INFILLS: INSTALL NEW FACE BRICK @ EXISTING MASONRY OPENINGS.
- FOUNDATION: REPAIR GAPS AS CONCRETE STEM WALL NEAR FOUNDATION
